REPAIRING ALUMINUM WIRING

U.S. Consumer Product Safety Commission
Bethesda, MD
www.cpsc.gov
www.SaferProducts.gov

Publication 516

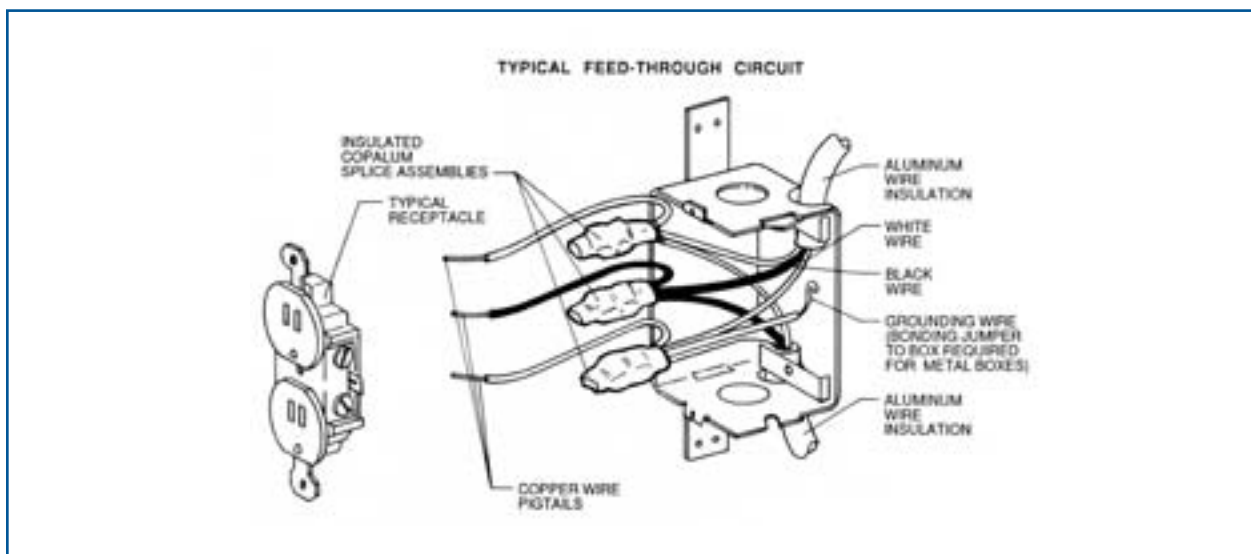
The tool is shown in the illustration below. An insulating sleeve is placed around the crimp connector to complete the repair. The copper wire pigtail is then connected to the switch, receptacle, or other termination device. An example of a repaired receptacle outlet is also illustrated below.

Recommended COPALUM Connector Repair

As an alternate to rewiring with copper, CPSC recommends attaching a short section of copper wire to the ends of the aluminum wire at connection points (a technique commonly referred to as “pig-tailing”), using a special connector named COPALUM to join the wires. CPSC staff considers pig-tailing with a COPALUM connector to be a safe and permanent repair of the existing aluminum wiring. The repair should include every connection or splice involving aluminum wire in the home, including outlets, dimmers, switches, fixtures, appliances, and junction boxes. The repaired system, with short copper wire extensions at every termination throughout the home, permits the use of standard wiring devices, including receptacles and switches.
